MILL CREEK DAM

NDI I.D. PA-0038

PHASE I INSPECTION REPORT
NATIONAL DAM INSPECTION PROGRAM

NAME OF DAM: Mill Creek Dam
STATE LOCATED: Pennsylvania
COUNTY LOCATED: Bradford
STREAM: Mill Creek, a secondary tributary of Susquehanna River
SIZE CLASSIFICATION: Small
HAZARD CLASSIFICATION: Significant
OWNER: Camp Spring Hill, Inc.
DATE OF INSPECTION: November 14, 1980 and February 5, 1981

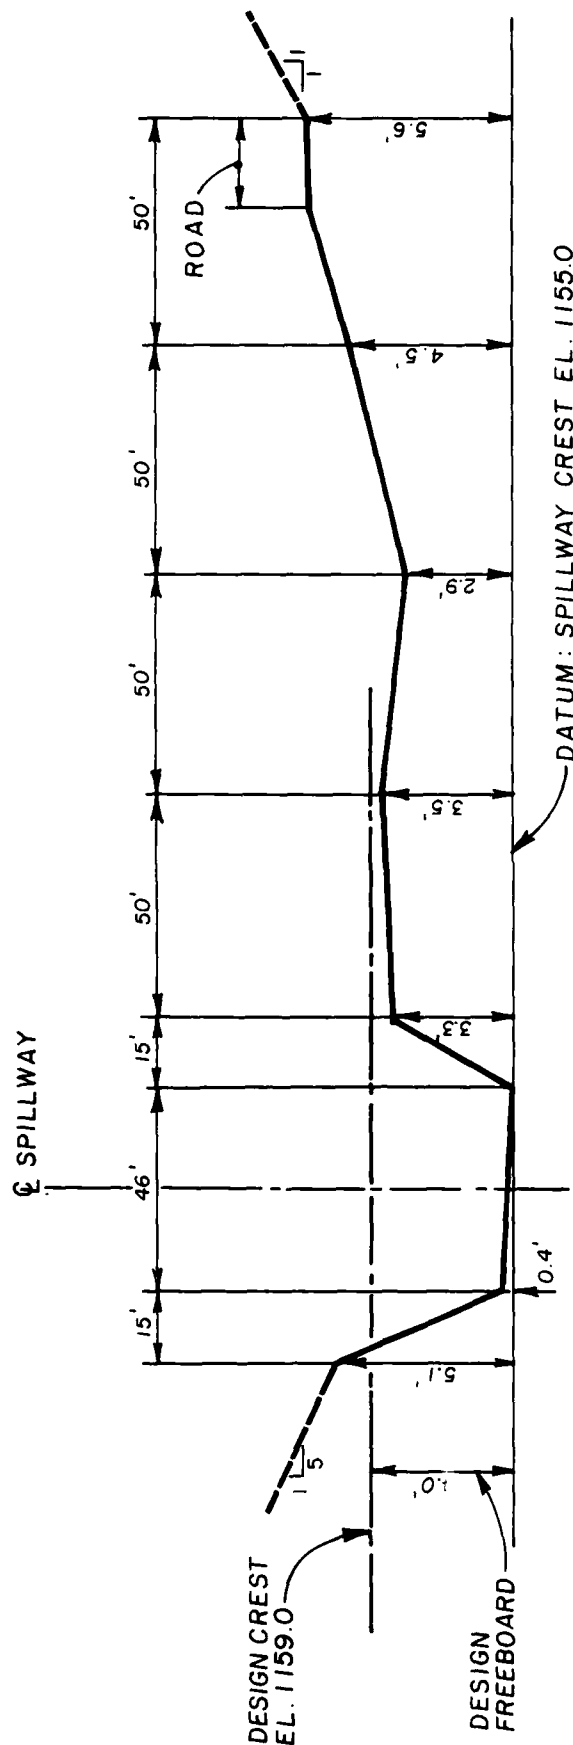
DAM CREST PROFILE (LOOKING DOWNSTREAM)

The crest of the dam was surveyed relative to the spillway crest elevation and it was found that approximately two-thirds of the embankment is approximately 1.0 foot below the design crest level. The dam crest profile is illustrated in Plate 5. The downstream slope of the dam was surveyed and found to be varying between 3 horizontal to 1 vertical and 2 horizontal to 1 vertical.

1. The owner should determine the nature and extent of improvements required to provide adequate spillway capacity. In the interim, the low areas on the crest of the dam should be scarified and filled with compacted fill.
2. The ponded water at the toe of the dam should be drained and the toe of the dam should be inspected for possible seepage. Necessary measures should be taken to control seepage, if it exists.
3. The operational condition of the low level outlet facilities should be evaluated and necessary maintenance performed. If the low level outlet facilities cannot be rendered functional, other means should be developed to drain the lake in the event of an emergency.
